SUPERFUND FIVE YEAR REVIEW REPORT

LEE'S LANE LANDFILL

LOUISVILLE, JEFFERSON COUNTY, KY

JUNE 2003

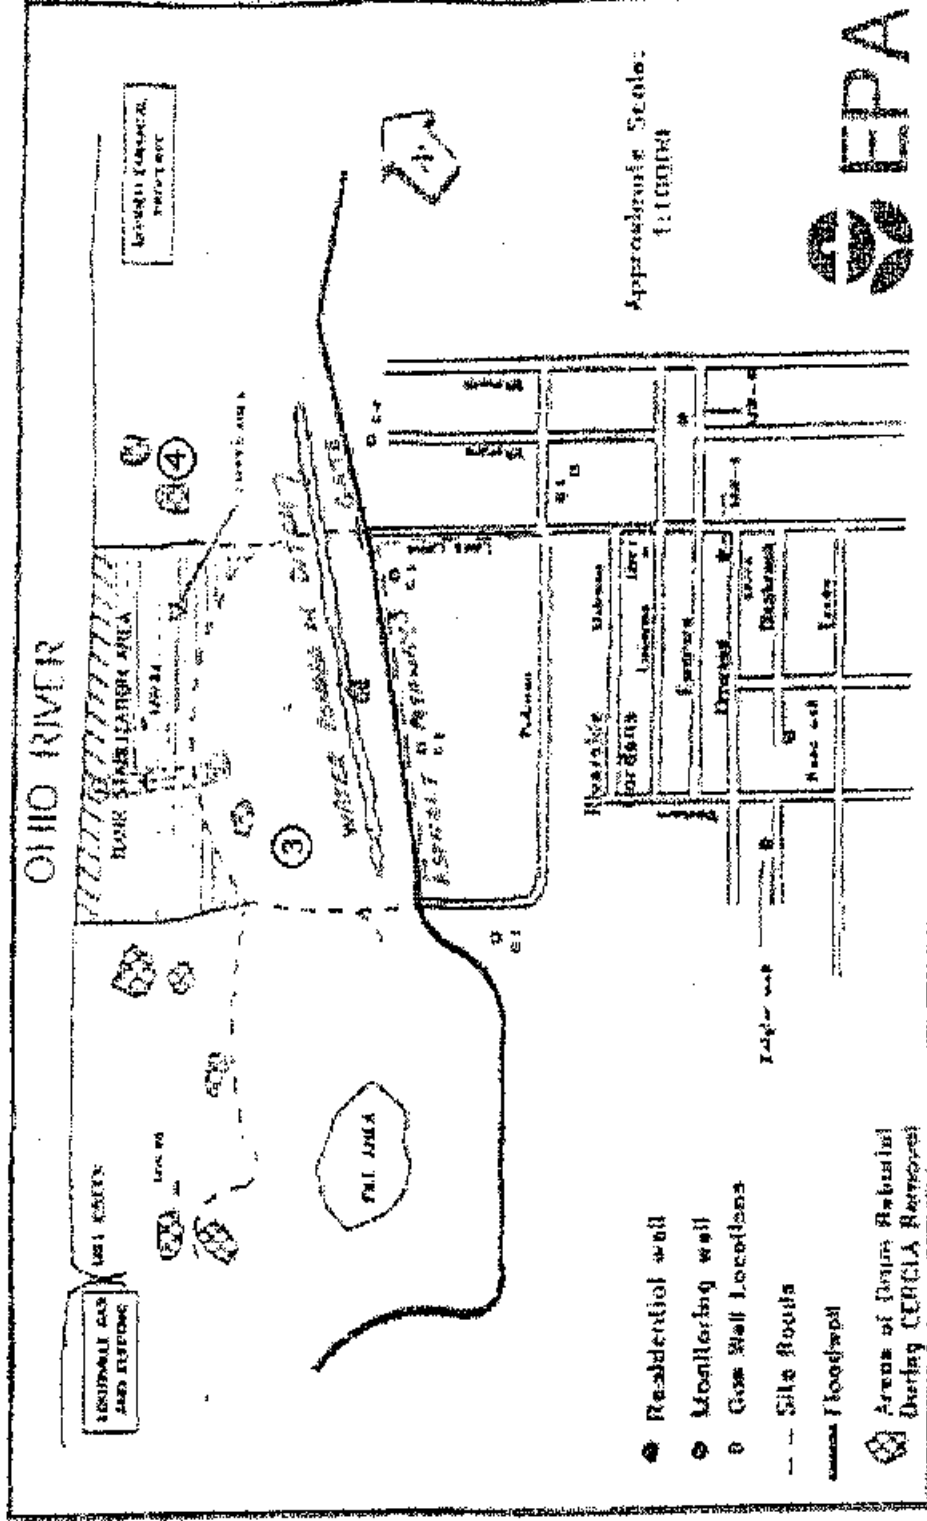
Figure 4
Site Inspection Map
Lee's Lane Landfill

- ③ ELASTIC MATERIAL OBSERVED AT SURFACE
- ④ BURIED DRUM WITH ELASTIC MATERIAL

- ② DITCH EXPOSED IN PRE-AREA
- ③ SEDIMENT BURIED ELASTIC DRAINAGE PIPE

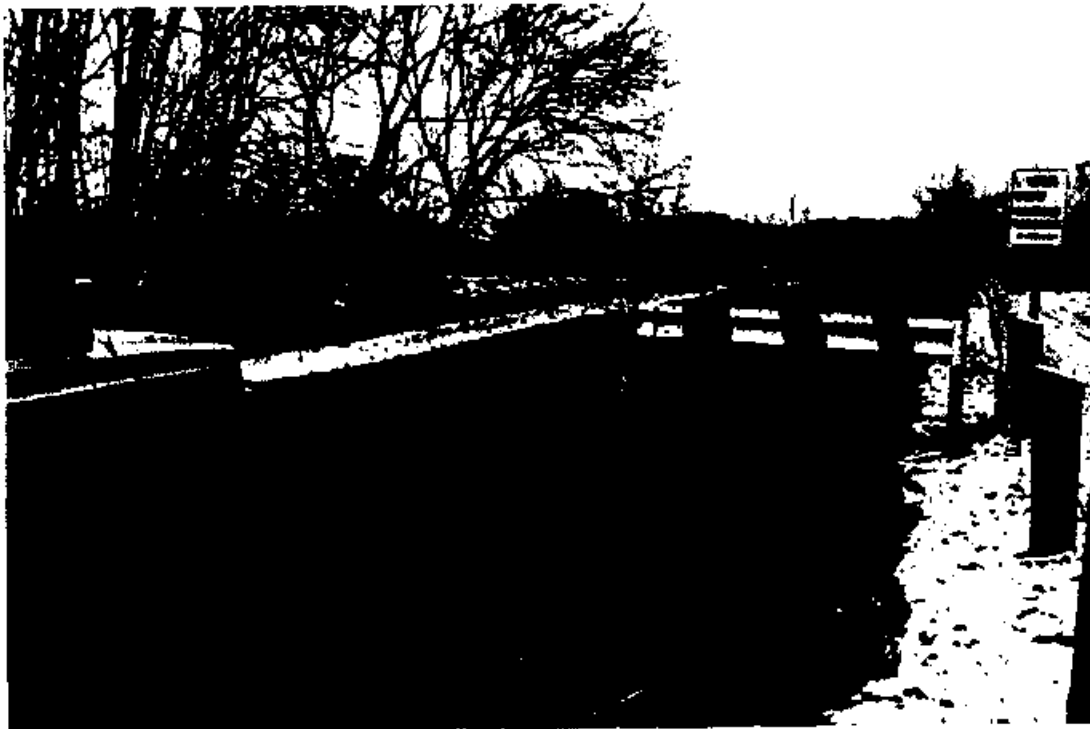
Photograph 1 - Entrance Gate at Lee's Lane

1. The access gate across the Lee's Lane entrance appears to be in good condition. It prevents motor vehicles from entering, but quad-runner ATVs can very easily go around the gates, see Photograph 1 and Figure 4.

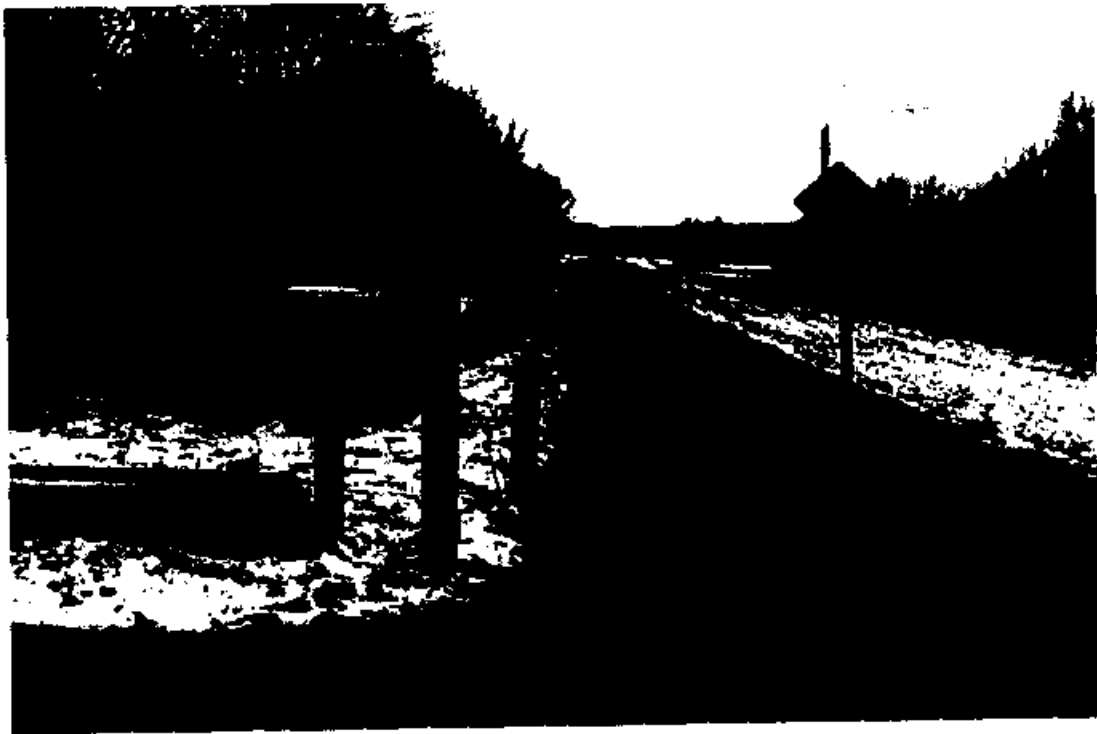
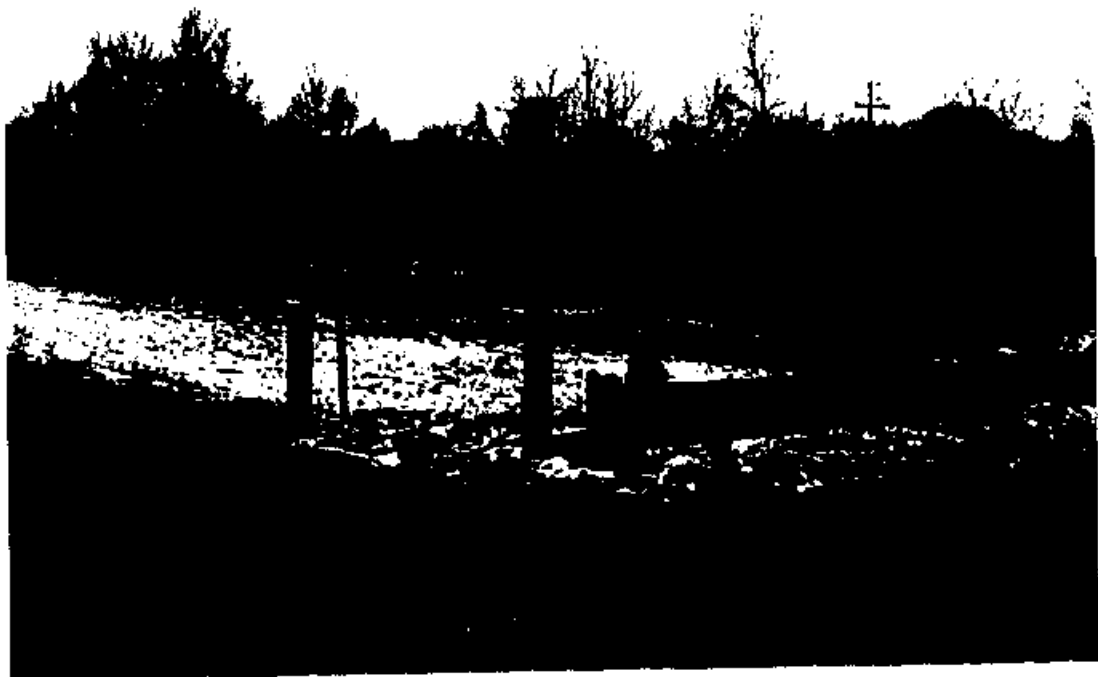
3. Although motor vehicles cannot travel along the asphalt path, pedestrians and quad-runner ATVs can. Cracking of the pavement indicates that it will begin to deteriorate rapidly under heavy traffic, see Photographs 5 and 6.

Photograph 5A - View Looking South Along the Levee from the Lee's Lane Crossing
Note Asphalt Walkout Along Top of Levee
